ARMY AVIATION TEST BOARD FORT RUCKER ALA
TEST OF T53-L-13 ENGINE (S/N LE-14083).(U)
NOV 68

SUBJECT: Letter Report of Test of T53-L-13 Engine (S/N LE-14083).
USATECOM Project No. 4-6-0150-05

DETAILED TEST RESULTS

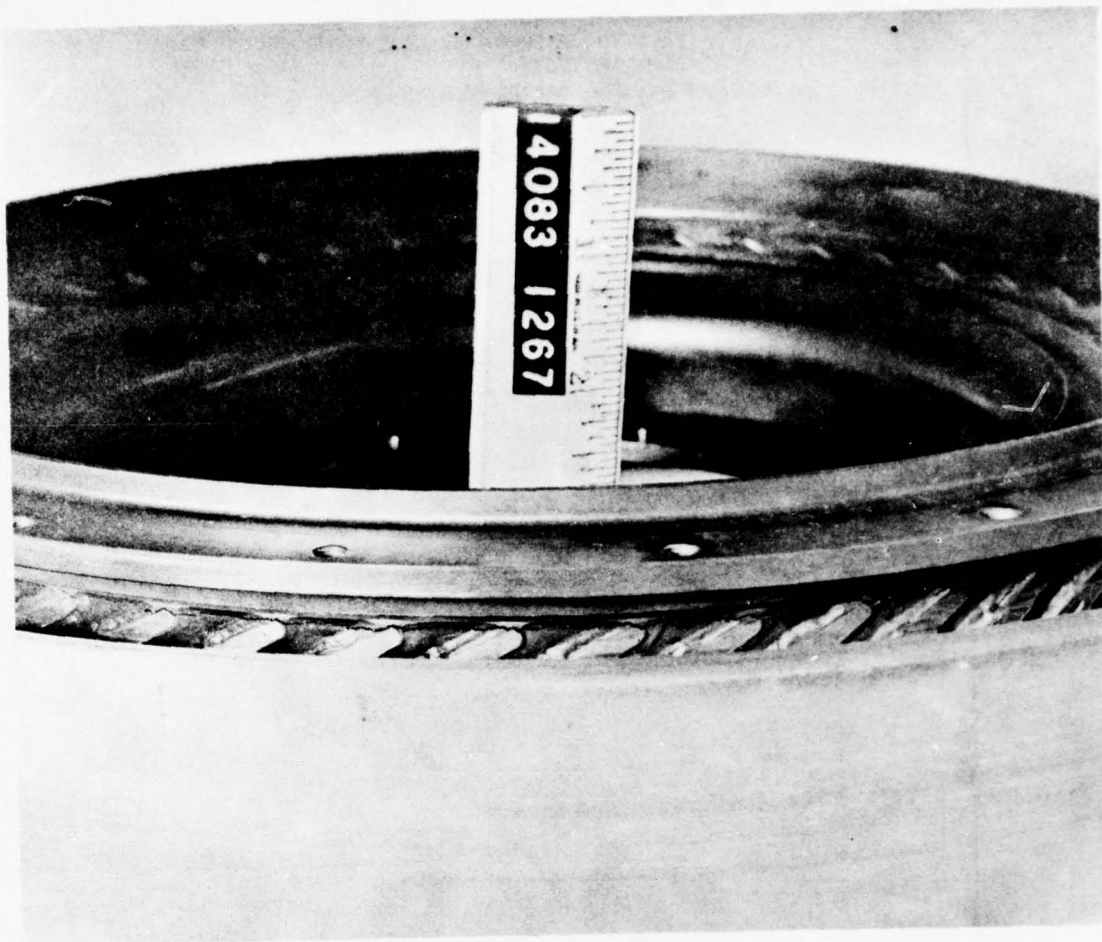
Figure 4.

<u>Nomenclature</u>	<u>FSN and P/N</u>	<u>Component Hours</u>	<u>Reason for Replacement</u>
First-Stage Gas-Producer (GP) Nozzle	2840-975-0258 1-110-520-14B	300.0	Circumferential cracking in outer shroud aft of vanes (figure 4).

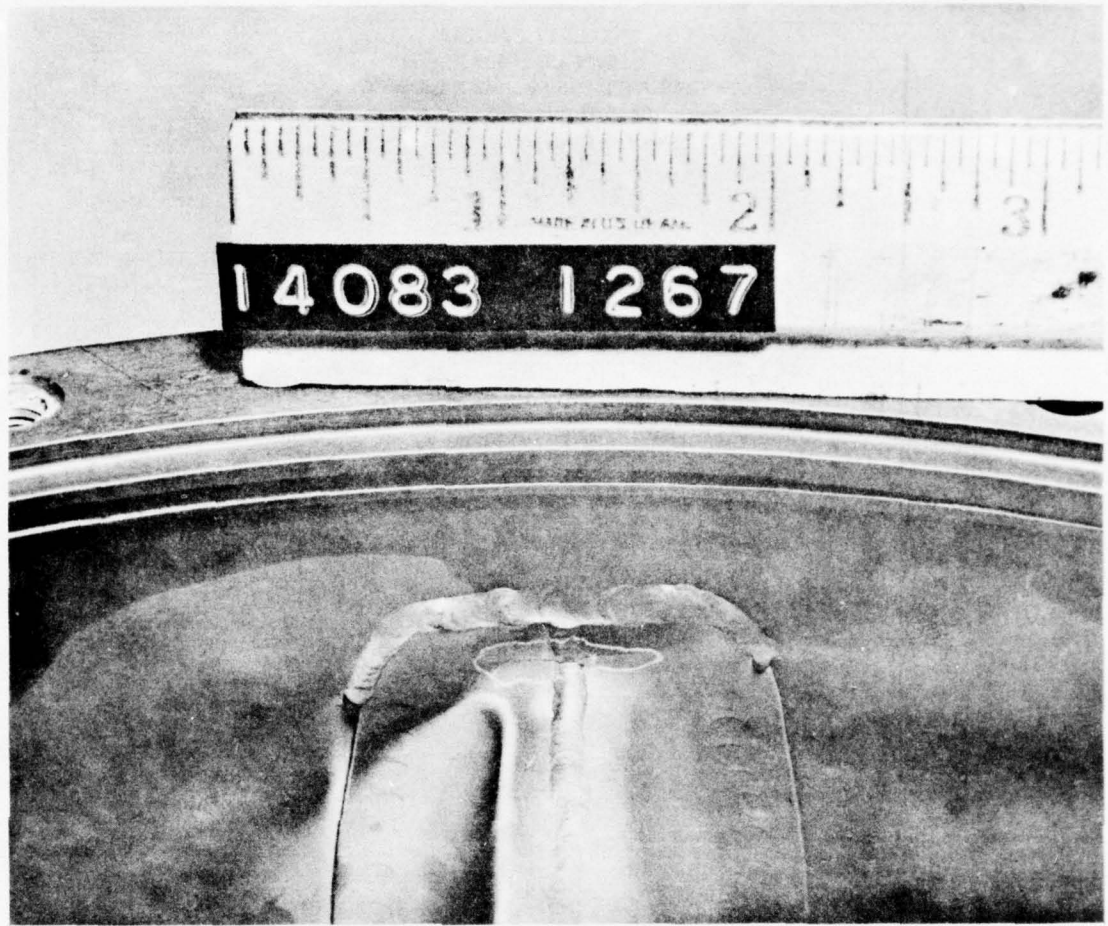
Figure 5.

<u>Nomenclature</u>	<u>FSN and P/N</u>	<u>Component Hours</u>	<u>Damage Exceeding TB</u>
Exhaust Diffuser	2840-925-5467 1-150-240-01E	300.0	5/8-inch crack extending circumferentially across weld in outer strut at outboard leading edge (figure 5).

Add: Circumferential cracks up to 3/4 inch are allowed on two outer struts at the leading edge outboard end of the outer strut. These cracks may cross the radial weld which is on the outer strut.

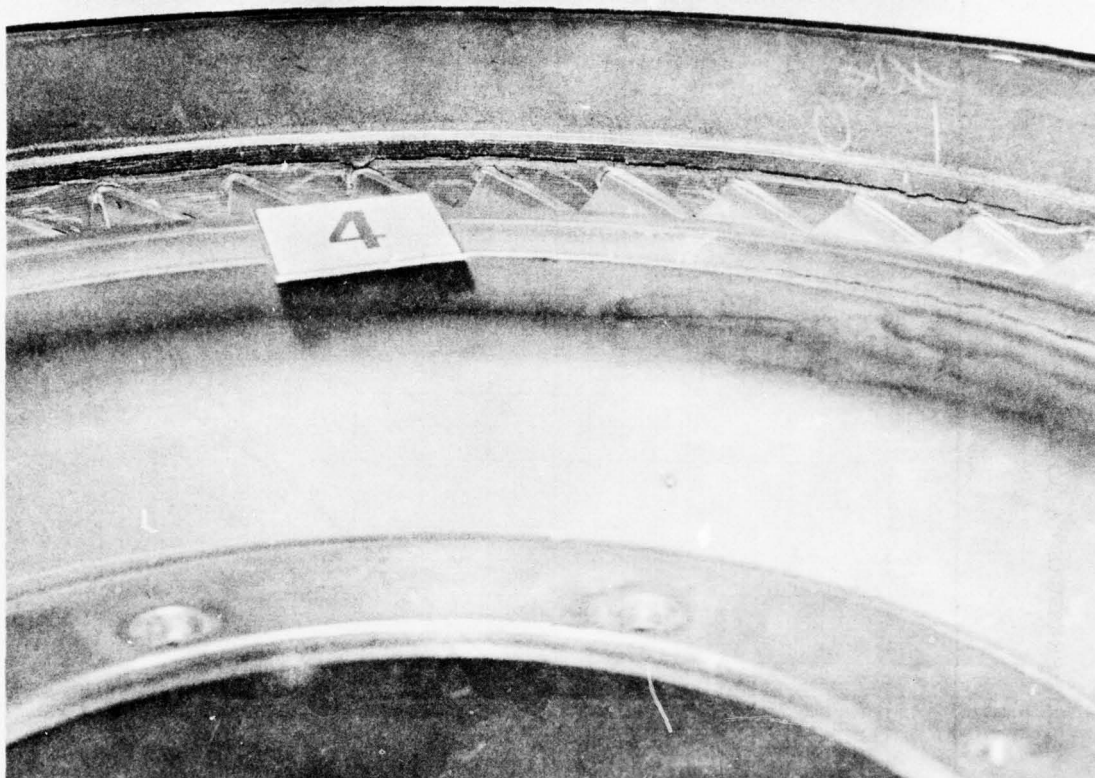
Figure 12.

<u>Nomenclature</u>	<u>FSN and P/N</u>	<u>Component Hours</u>	<u>Reason for Replacement</u>
		<u>Nozzle Less Curl</u>	
First-Stage GP Nozzle	2840-975-0258 1-110-520-14M	407.3 <u>Curl</u> 257.3	190 degrees of circumferential cracking in outer shroud aft of vanes (figure 12).

e. The increase in referred EGT was symptomatic of the severe circumferential cracking in the first-stage GP nozzle and the associated tip rubbing of the first-stage GP rotor. It should be emphasized again that the rise in EGT was not evident to the pilot. Only by referring the EGT and comparing it to a baseline EGT did the increase become apparent.

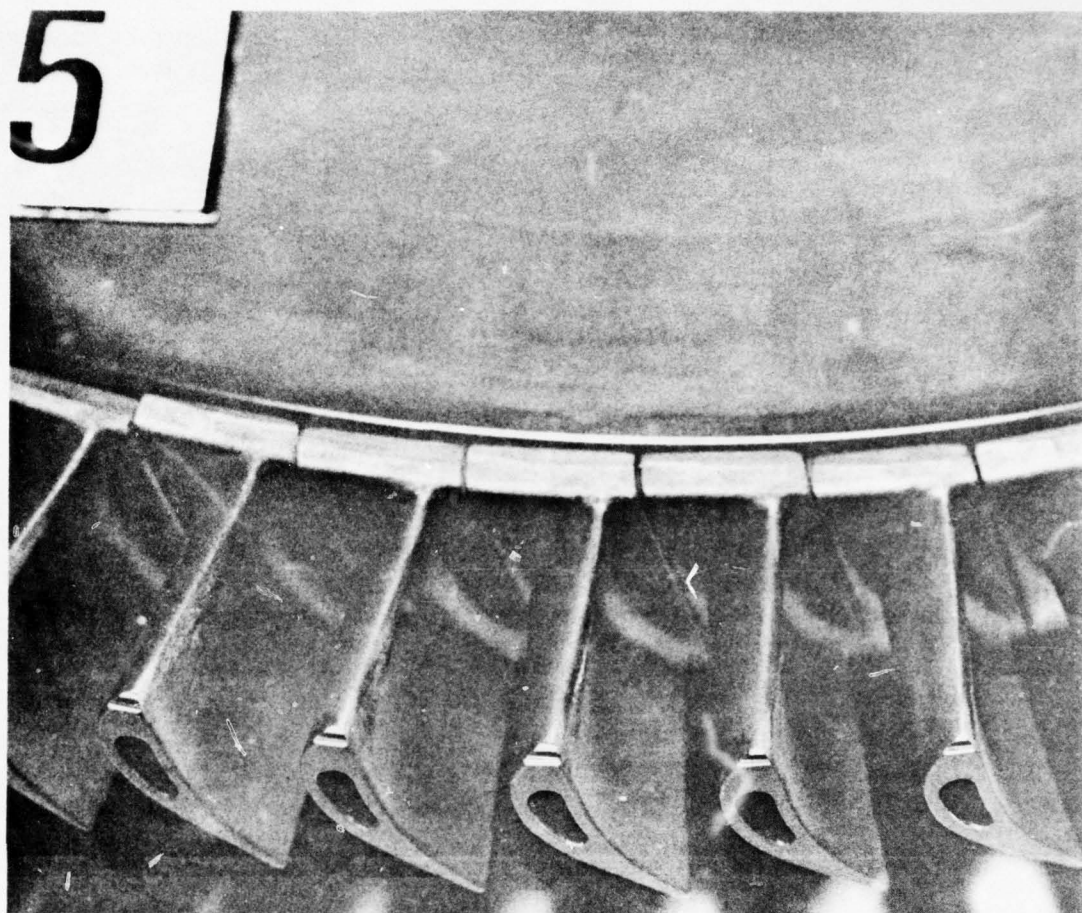
Figure 13.

<u>Nomenclature</u>	<u>FSN and P/N</u>	<u>Component Hours</u>	<u>Damage Exceeding TB</u>
First-Stage GP Rotor	2840-924-8647 1-100-880-01C	557.3	Blade tip rub up to 3/64 inch at leading edge of blades (figure 13).
Second-Stage GP Nozzle	2840-925-9665 1-120-000-06D	557.3	Two cracks extending completely across inner shroud with up to 1/2 inch of cracking in vane brazement. Both inner shroud cracks extended into the front support 7/32 to 3/8 inch and into the aft support 5/32 to 13/32 inch (figures 14 and 15).
Second-Stage Power-Turbine (PT) Nozzle	2840-943-2382 1-140-470-05E	557.3	Two 5/8-inch cracks in inner shroud and vane brazements (figure 16).
Exhaust Diffuser	2840-925-5467 1-150-240-01E	557.3	Two cracks extending across two struts at out-board leading edge. Both extended across weld and measured 1/2 and 3/4 inch (figure 17).

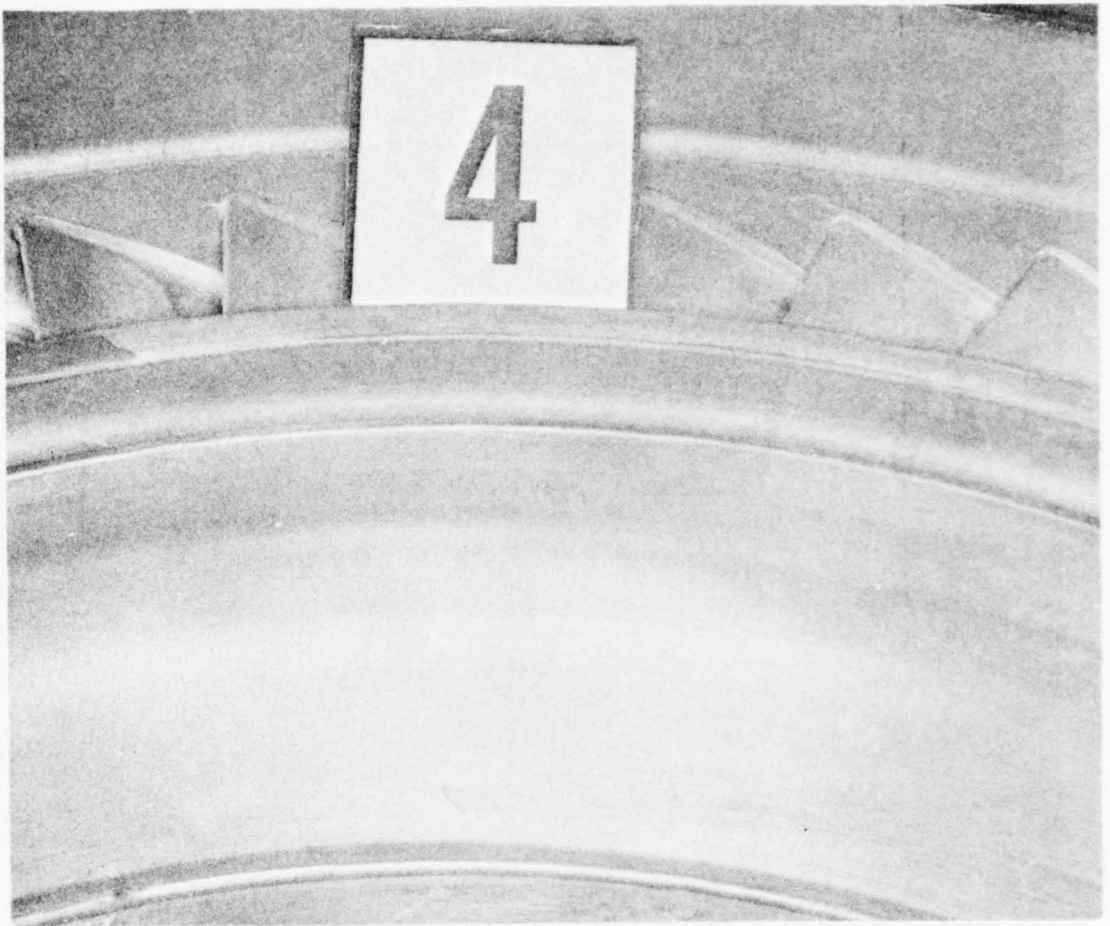
Figure 21.

<u>Nomenclature</u>	<u>FSN and P/N</u>	<u>Component Hours</u>	<u>Damage Exceeding TB</u>
First-Stage GP Nozzle	2840-975-0258 1-110-520-14D	340.1	Two circumferential cracks, 3 1/2 and 4 inches, in channel inboard of vanes on aft side (figure

<u>Nomenclature</u>	<u>FSN and P/N</u>	<u>Component</u>	
		<u>Hours</u>	<u>Damage Exceeding TB</u>
			21). Cracks extended into the outer shroud from the trailing edge brazement of 15 vanes circumferentially up to a distance of 3/8 inch into the outer shroud (figure 22).
Second-Stage GP Nozzle	2840-925-9665 1-120-000-06D	897.3	Three cracks extending across inner shroud with up to 1/2 inch of cracking in vane brazement (figure 23). Two of these cracks extended into both the front and aft supports. One extended only into the front support. The cracks extended between 7/32 and 25/32 inch into the forward inner support and between 3/8 and 1/2 inch into the aft inner support (figures 24 and 25). Thirty-nine vanes had brazement cracks extending 5/16 inch in the outer shroud at the leading edge. At 17 vanes, these brazement cracks extended axially up to 5/32 inch into the outer shroud (figure 26).
First-Stage PT Nozzle	2840-944-7296 1-190-000-09C	897.3	All vanes had cracks of up to 7/16 inch in the vane brazements in the outer shroud at the leading edge. At one vane

Add: Cracks up to 1/4 inch, which extend from the vane brazements at the trailing edge into the outer shroud, are allowable at no more than 15 vanes.

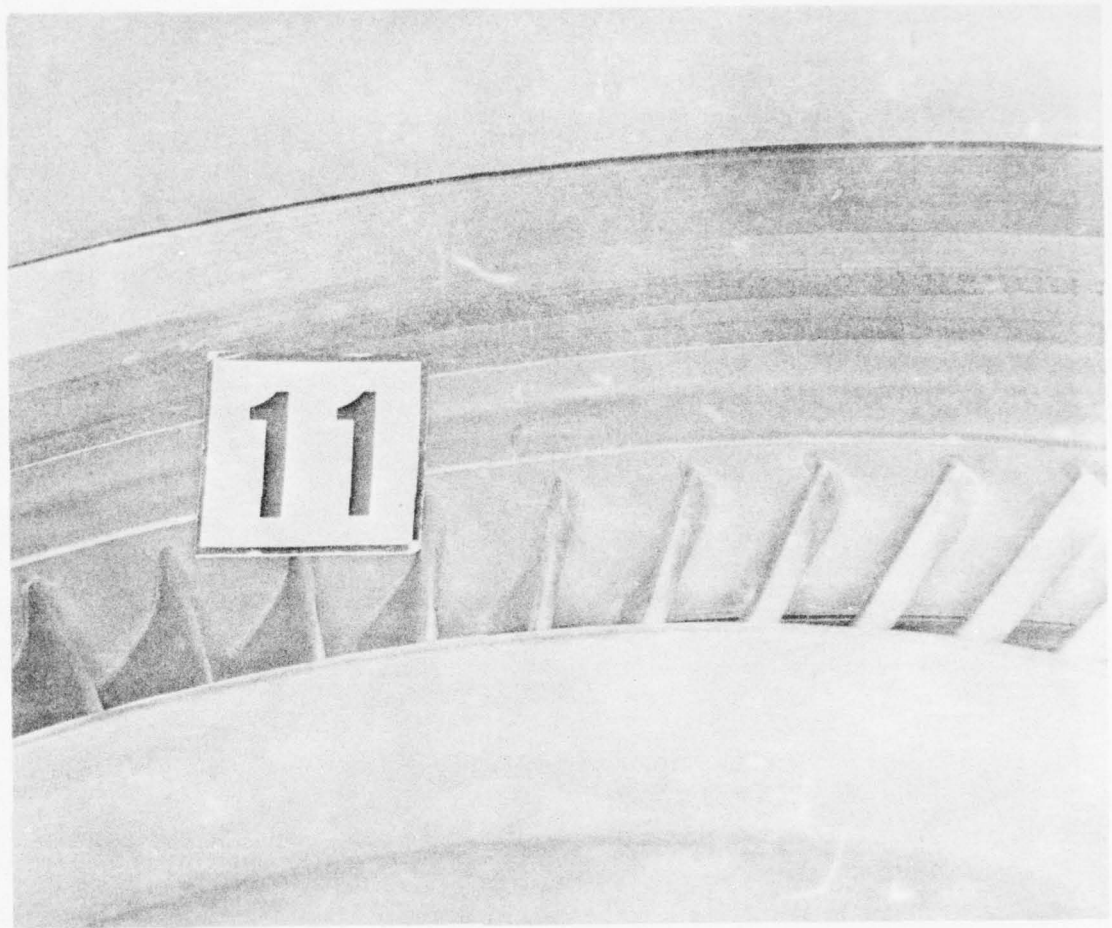
Figure 27.

<u>Nomenclature</u>	<u>FSN and P/N</u>	<u>Component Hours</u>	<u>Damage Exceeding TB</u>
			the brazement crack extended 5/16 inch axially into the outer shroud at the vane leading edge (figure 27).
Second-Stage PT Nozzle	2840-943-2382 1-140-470-05E	897.3	Three cracks extended across the inner shroud 23/32, 23/32, and 11/16 inch (figure 28).
Exhaust Diffuser	2840-925-5467 1-150-240-01E	897.3	Two cracks extended across two struts at the outboard leading edge. Both extended across the weld and measured 27/32 and 3/4 inch (figure 29).

<u>Nomenclature</u>	<u>FSN and P/N</u>	<u>Component Hours</u>	<u>Damage Exceeding TB</u>
			had brazement cracks which extended from the leading edge of the vanes up to 1/2 inch into the outer shroud (figure 27).
Second-Stage PT Nozzle	2840-943-2382 1-140-470-05	1,500.7	Although damage to this nozzle at 1,199.3 hours met field serviceability criteria available to the manufacturer, such criteria were not available to the USAAVNTBD at the 1,500.7-hour inspection. The damage exceeding available criteria was: Three cracks extended across the inner shroud radially down the inner support 23/32, 23/32, and 11/16 inch (figure 28).
Exhaust Diffuser	2840-925-5467 1-150-240-01E	1,500.7	Two struts had cracks of 13/16 and 1 inch in the leading edge at the outer shroud (figure 29).

<u>Nomenclature</u>	<u>FSN and P/N</u>	<u>Component Hours</u>	<u>Damage Exceeding TB</u>
			<p>into the outer shroud axially at the leading edge of the vanes; however, they did not extend over the step. Ten cracks extended over the edge of the step up to 3/8 inch from the vane leading edge. Two vanes had brazement cracks of 5/16 and 15/16 inch at the inner shroud. Two other vane brazement cracks extended into the outer shroud to both the leading and trailing edges, completely across the outer shroud. (These type cracks are shown in figures 36 and 37.)</p>
First-Stage PT Nozzle	2840-944-7296 1-190-000-09C	1,808.3	<p>All vanes had brazement cracks in the outer shroud. A number of these cracks extended into the outer shroud up to 1/2 inch from the vane leading edge. Four of these extended over the edge of the outer shroud and between 5/32 and 3/8 inch into its vertical face. (These cracks were previously shown in figure 27.)</p>

To read: All vanes may have axial cracks extending from brazement cracks at the vane leading edge in the outer shroud provided that no more than 10 such cracks extend onto the vertical face of the outer shroud more than 3/8 inch.

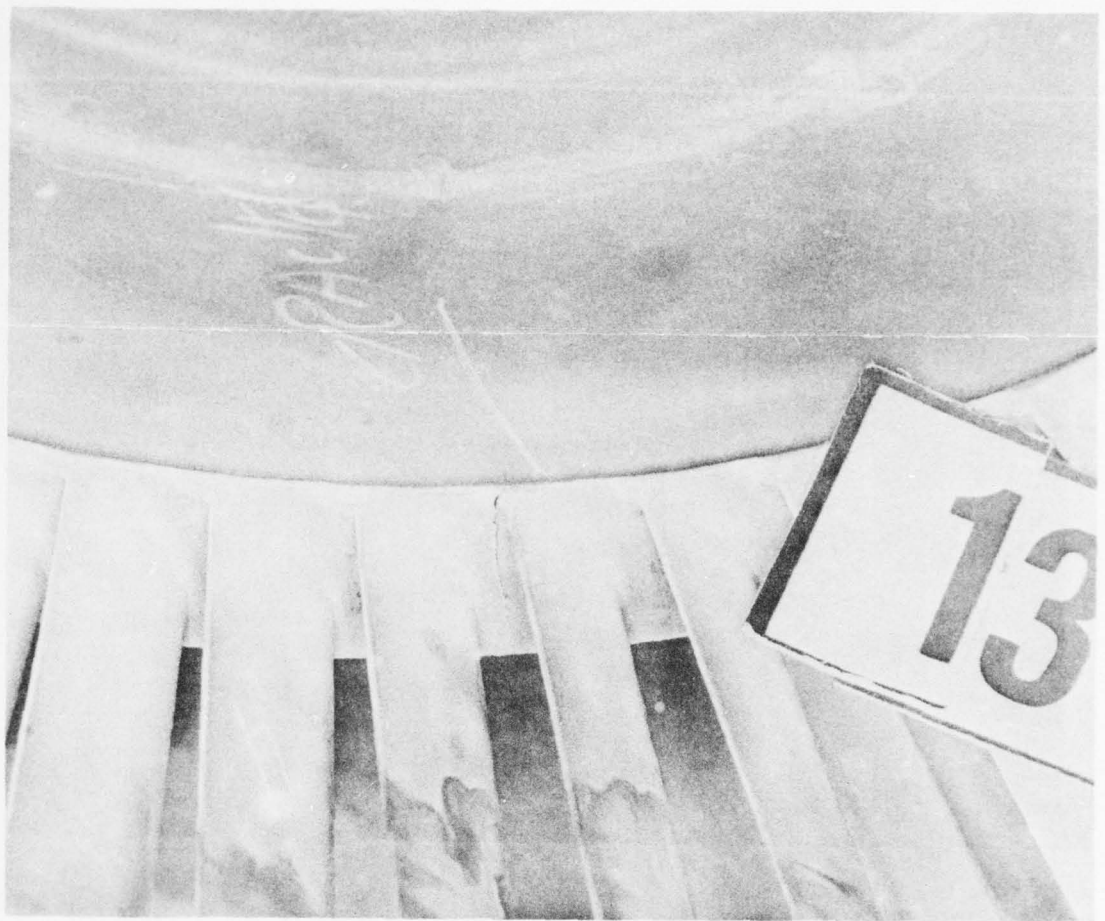
Figure 28.

<u>Nomenclature</u>	<u>FSN and P/N</u>	<u>Component Hours</u>	<u>Damage Exceeding TB</u>
			21/32 and 3/4 inch radially down the inner support (figure 28).
Exhaust Diffuser	2840-925-5467 1-150-240-01E	1,808.3	Two struts had cracks in the leading edge at the outer shroud. One extended 1 inch circumferentially. The other crack extended 1 1/8 inch circumferentially (figure 29). Another crack, forward of the previous crack and located in the mid cone, extended 1 11/16 inch circumferentially. At the midpoint of this crack, a crack branched 1/4 inch axially to the strut weld and then extended out 1 inch along the strut weld into the mid cone at a 45-degree angle to the strut (figure 45).

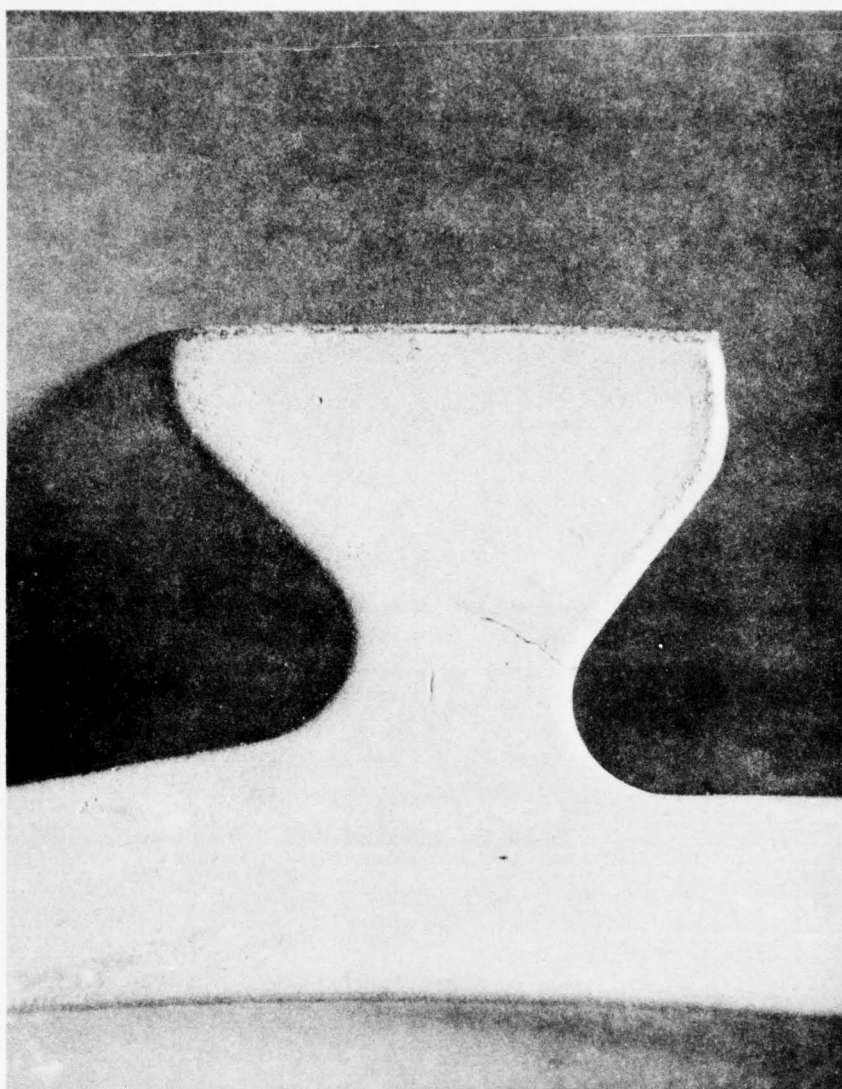
Figure 32.

<u>Nomenclature</u>	<u>FSN and P/N</u>	<u>Component Hours</u>	<u>Reason for Replacement</u>
Face Plate	2840-924-3649 1-030-067-02	1,199.3	Several scratches on seal contact area. Repair method exists but is uneconomical.
Lock	2840-735-6543 1-060-119-01	1,199.3	Replaced with new configuration lock (ECP LY-GT-152).
Accessory Gear Cover Assembly	2840-949-5459 1-080-330-06	1,199.3	Acceptable to overhaul standards; however, part was replaced due to a machine error during rework to incorporate ECP's LY-GT-142 and -148. Assembly, P/N 1-080-330-01, was installed on rebuild.
No. 1 Bearing	3110-727-3032 1-300-015-04	1,199.3	Bearing was serviceable, but was replaced to install a new configuration bearing with an outer race riding cage.
Second-Stage Disc Assembly	FSN not available. 1-100-710-04	1,199.3	Cracks in tenons at five positions. Cracks were similar to those shown in figure 32. New 34-blade disc installed (ECP LY-GT-161).

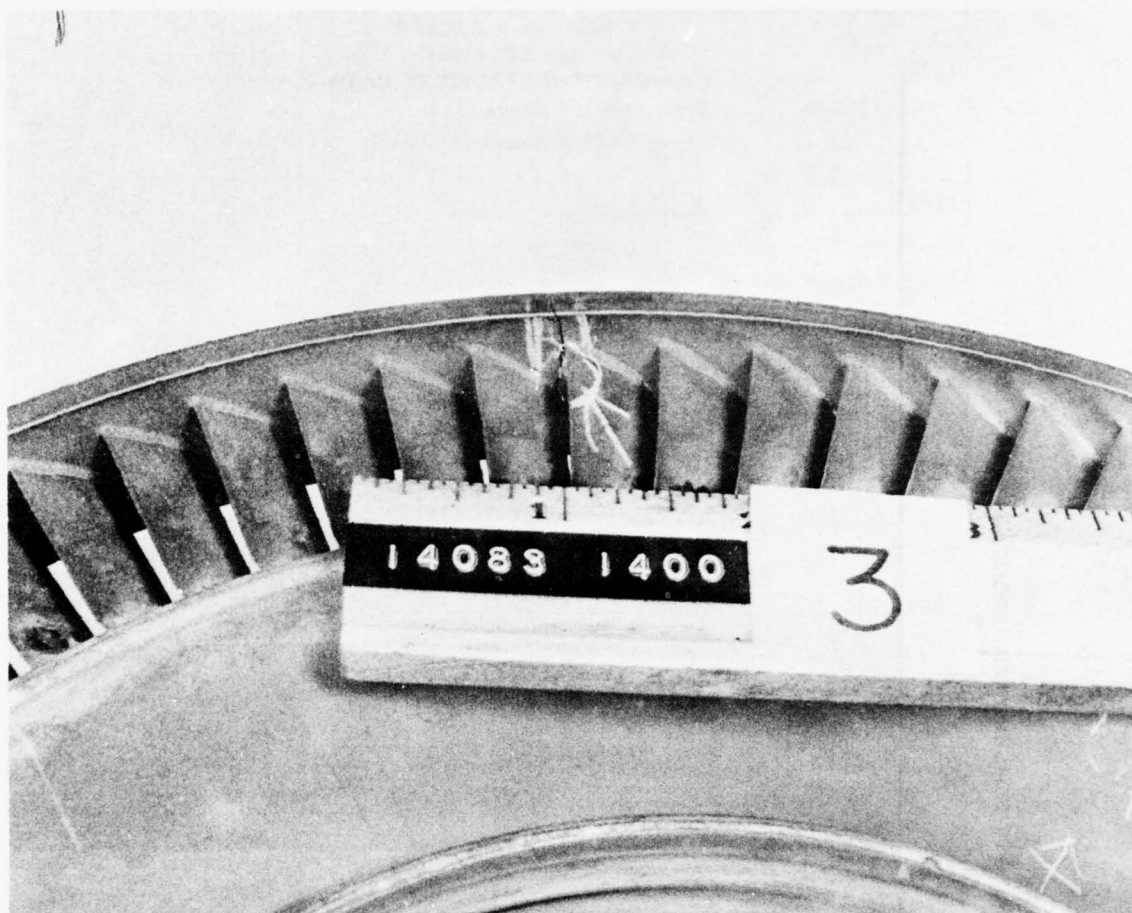
Figure 39.

<u>Nomenclature</u>	<u>FSN and P/N</u>	<u>Component Hours</u>	<u>Damage Exceeding TB</u>
			of the outer shroud. Five of these type cracks extended over the edge of the step at the leading edge of the nozzle up to 11/32 inch from the vane leading edge (figure 38). Three vane brazement cracks extended axially up to 1/2 inch toward the trailing edge of the nozzle (figure 39).

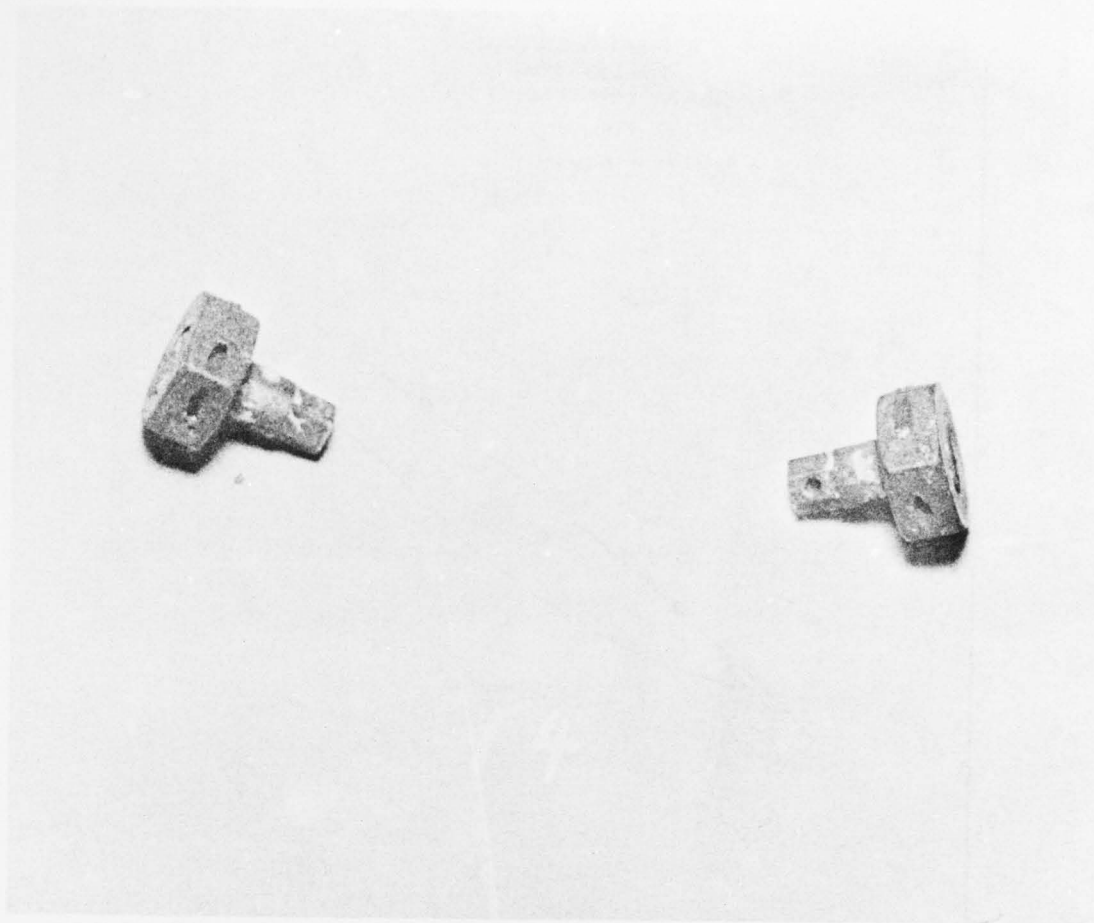
Figure 42.

c. The only parts replaced at the 1,500.7-hour inspection were the two retaining studs on the aft side of the No. 2 bearing housing (ECP LY-GT-136). Both studs had failed (figure 42). They had been installed for 301.4 hours. The same type studs (ECP-136) were installed.

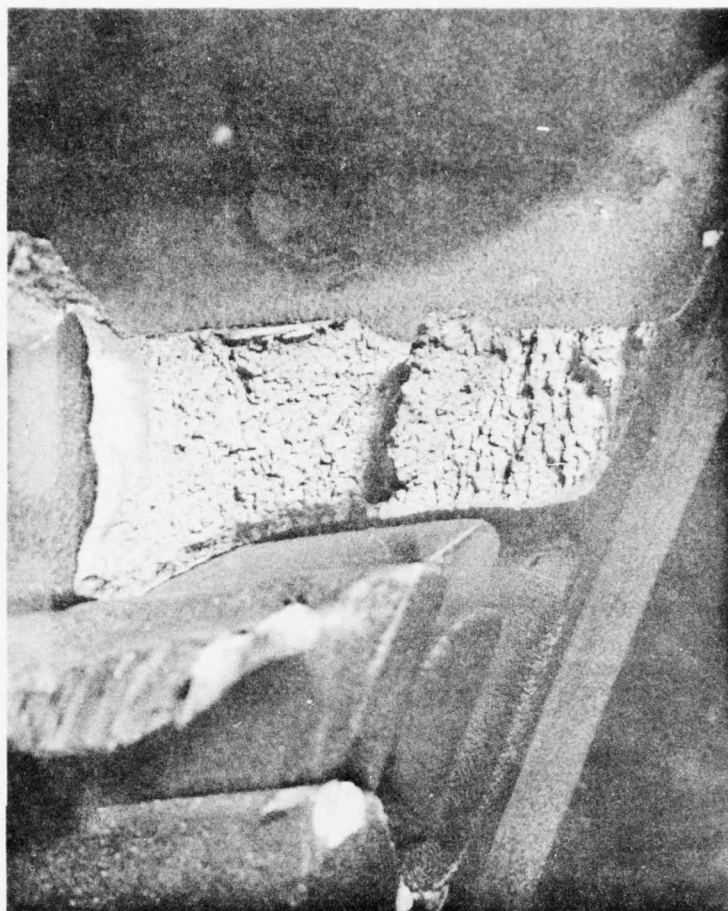
Figure 52.

c. Inspection at the manufacturer's plant revealed that the engine had experienced a fourth-stage compressor disc tenon failure. All the blades in the fourth and fifth stages were broken at the base. Extensive damage was present in the third-, fourth-, and fifth-stage stators. The centrifugal compressor had extensive damage and the hot-end was burned up. Figure 50 shows the compressor and figure 51 shows the failed tenon. The manufacturer stated that evidence of fatigue and stress corrosion were present and that the N_1 overspeed reported at 1,010.0 engine hours might have contributed to the failures. Figure 52 shows a close-up of the failed tenon.

b. The fourth-stage disc of the T53-L-13 TBO test engines at the USAAVNTBD be debladed, stripped, and liquid dye-penetrant inspected at 1,500 disc hours.
